NEW HOME FOR RUSSIAN ICONS

Historic building gutted and re-roofed to house unique museum in Clinton, Mass.

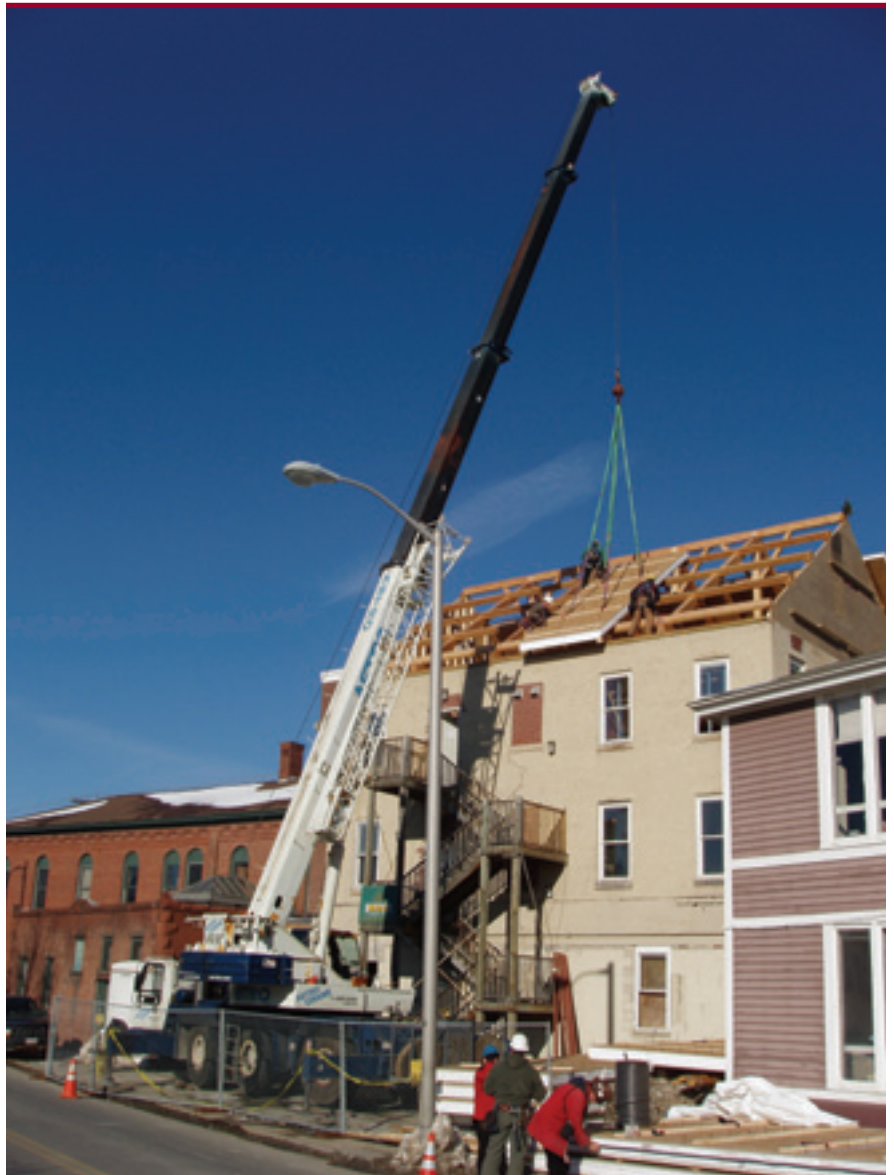
Benson Woodworking crew employs a Krupp crane provided by Astro Crane to position roof panels for Museum of Russian Icons in Clinton, Mass.

Benson Woodworking fabricated the structure's four new heavy timber trusses in their Walpole shop and erected the trusses together with prefabricated, insulated wood roof panels.

Roof panels, measuring 8 feet by 24 feet, are made of 1/2-inch-thick OSB wood skins that sandwich an 8-inch-thick expanded polystyrene foam insulation. Panels are rated at R-30. Gaskets plus OSB splines are wrapped around each panel ensuring air-tight seams. Extra long screws hold the 9-inch-thick panels to the roof purlins.

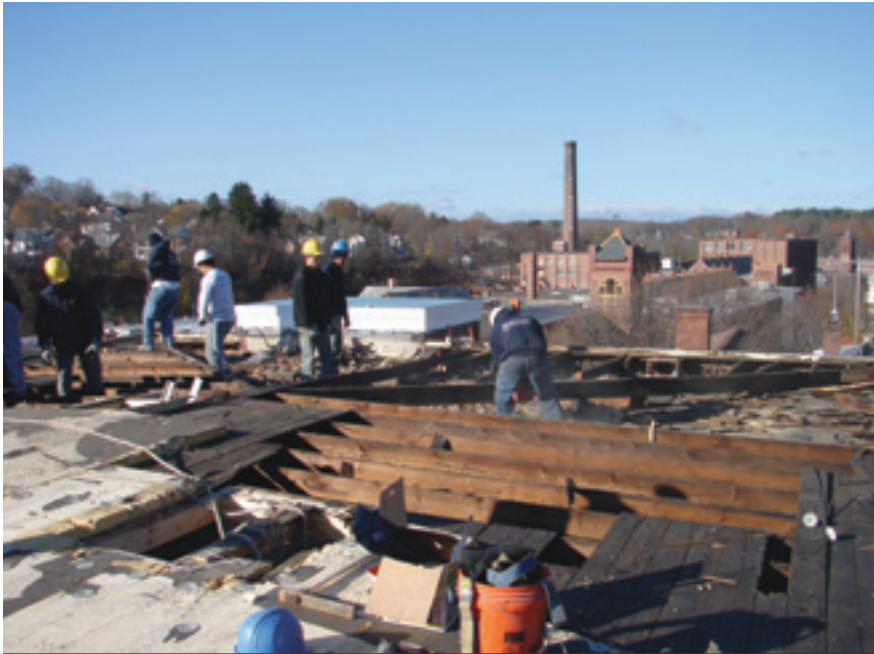
Top left: Murray Brothers Construction workers demolish roof of old mill building being converted into museum.

Subcontractor Murray Brothers is responsible for the demolition of all interior walls and partitions, and for reinforcing the building's existing frame. As part of this effort, they inserted steel I-beams between existing wood floor joists and supported them on new steel

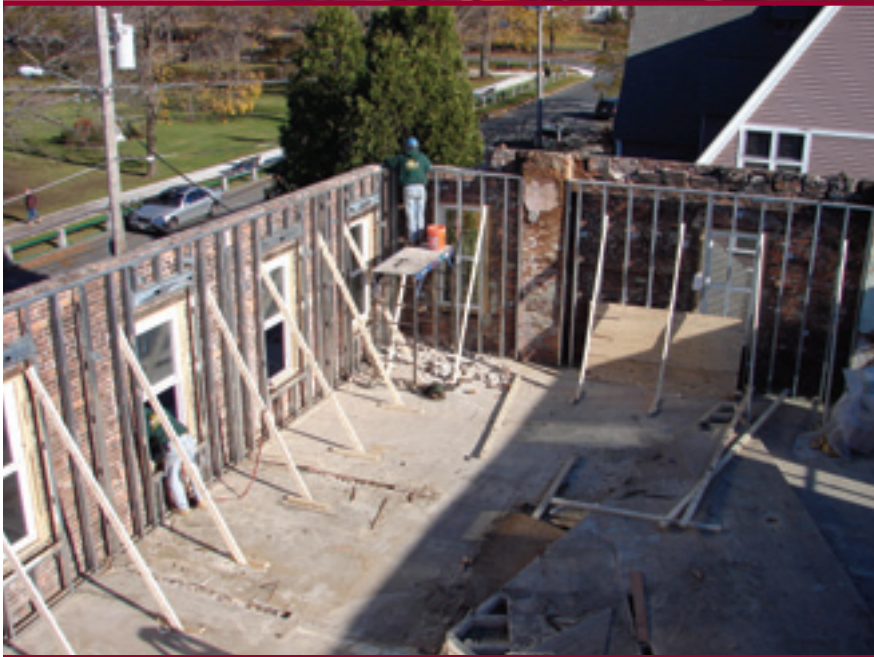
Middle left: With roof demolished, workers reinforce existing wall frames and place new roof plate on walls.

tube columns. The Leominster company also fabricated the two end gables, and installed new, 2-inch by 14-inch glued laminated timber roof plates on the perimeter bearing walls to support new roof trusses.

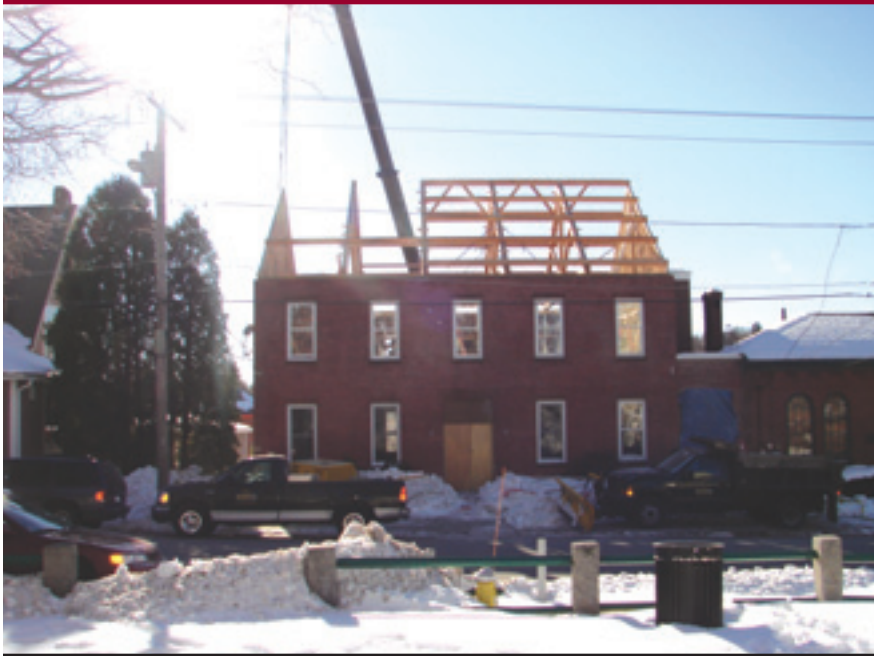
Bottom left: Photo of front of building shows three trusses and one gable in place.

Benson’s crew initially raised two of the trusses to the third floor, placing them in the center bay and tying them together with 6-inch by 8-inch purlins. A third truss was hoisted in place and tied to the first pair with additional purlins. With this done, one of Murray’s

gables was raised, set in place and joined to the three trusses with more purlins. The fourth and final truss was then raised and tied to the others, followed by the hoisting and the attachment of the other gable. This completed the roof frame, which was now stable and strong enough to receive the prefabricated wood panels.

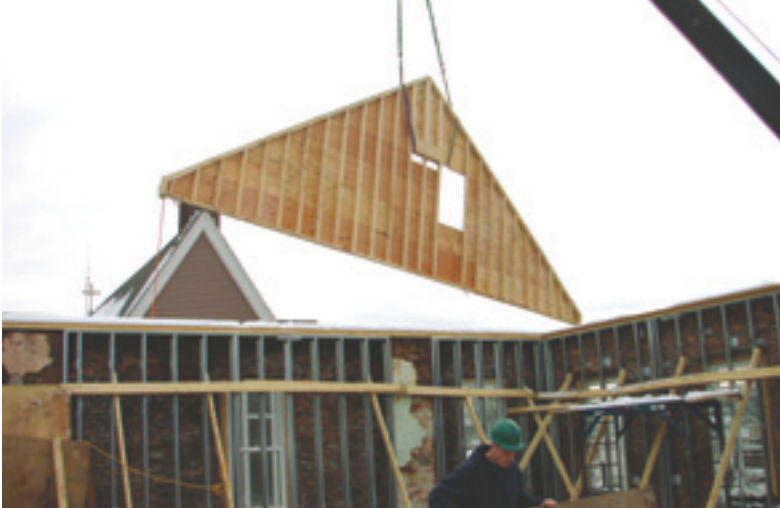
For lack of space, gable end walls were fabricated on third floor, then lowered to alleyway at street level until ready for final positioning.

Murray Brothers faced the same challenge. For lack of space, they had to fabricate the two gable end walls one at a time on the third floor, then have the crane lower the gables to the alleyway until the trusses were in place.

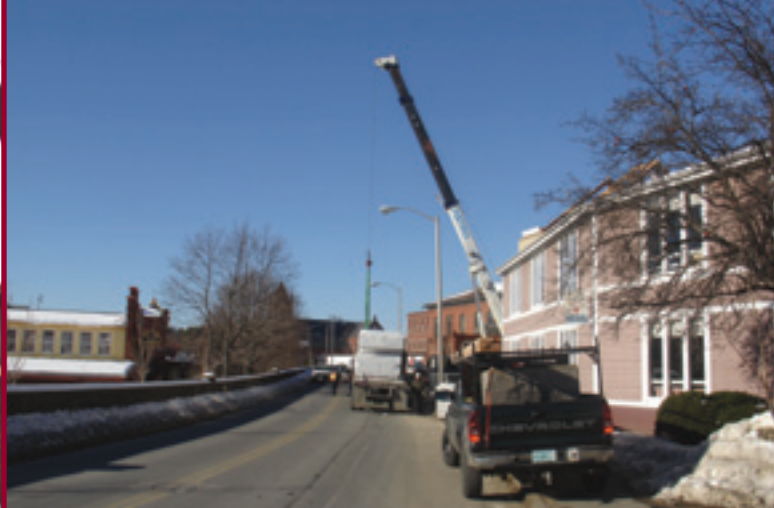
Police detail closes off one-lane of narrow section of Route 62 as crane unloads pallet of prefabricated roof panels.

“This is a very tight site,” explained Ben Brungraber, professional engineer for Benson who designed the trusses and planned the construction procedure. “We have to have a police detail on the job while the crane is offloading and raising trusses and roof panels, because sometimes one lane of two-lane Route 62 has to be shut down.”

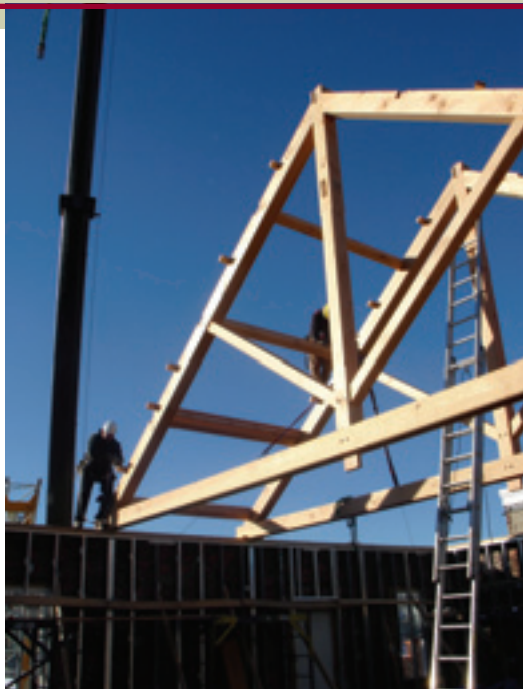
First two trusses are tied together with 8-inch by 8-inch purlins.

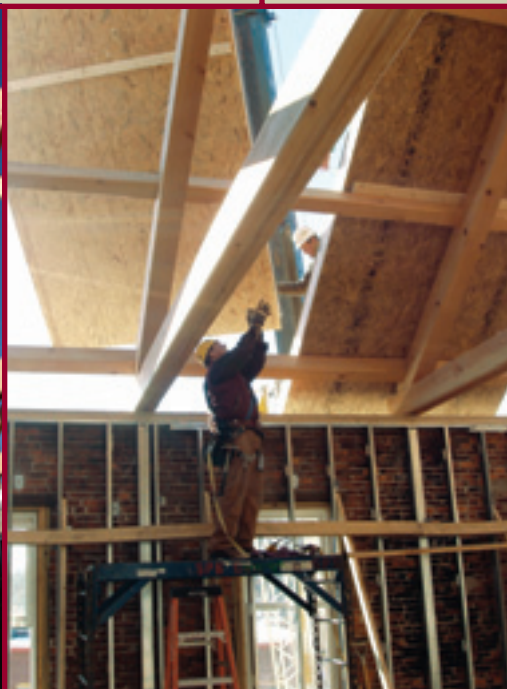
Workers guide an 8-foot by 24-foot roof panel into position on purlins.

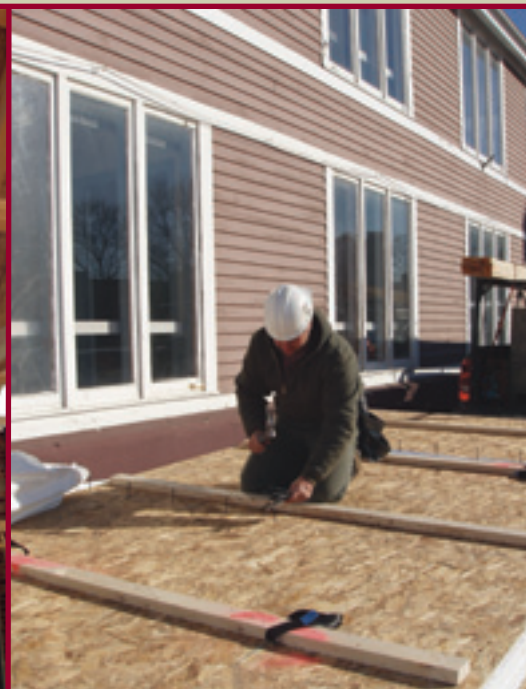
Duane Beiler pre-installs extra-long screws that will later be driven to hold panels to purlins.
